AFFDL-TR-79-3118
Volume III

DURABILITY METHODS DEVELOPMENT
VOLUME III
STRUCTURAL DURABILITY SURVEY:
STATE-OF-THE-ART ASSESSMENT

B. J. PENDLEY
S. P. HENSLEE
S. D. MANNING
GENERAL DYNAMICS CORPORATION
STRUCTURAL AND DESIGN DEPARTMENT
FORT WORTH DIVISION
FORT WORTH, TEXAS

TECHNICAL REPORT AFFDL-TR-79-3118, VOL. III

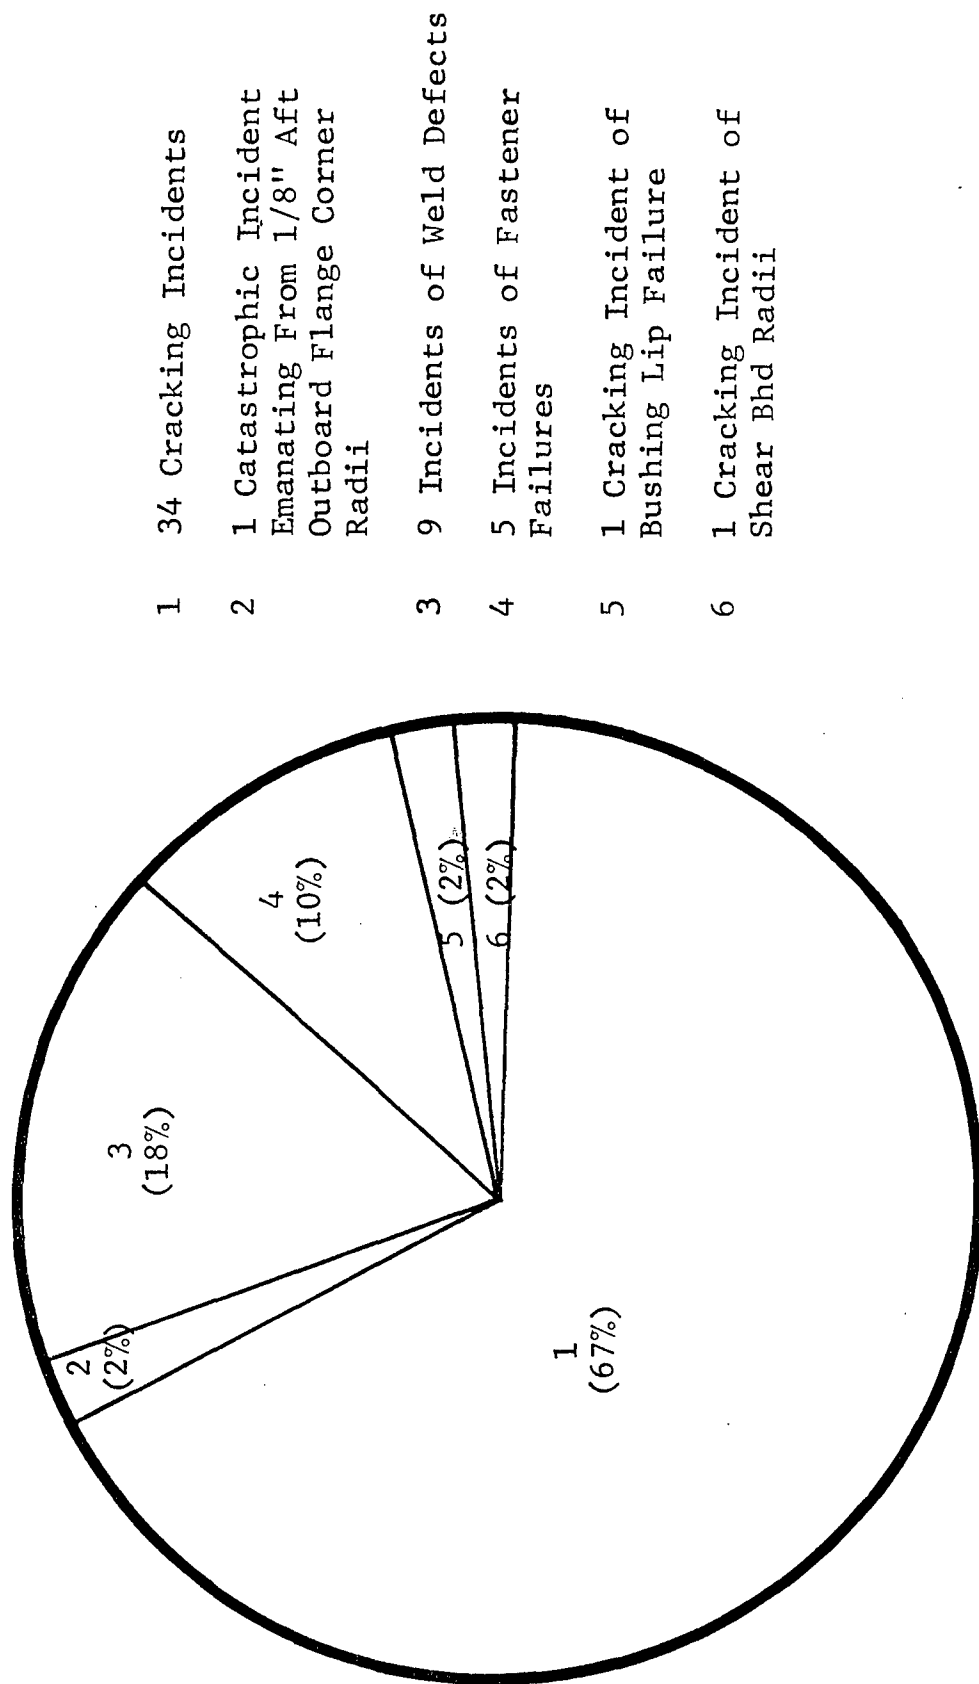
FIGURE 11 F-111A (FW#2) Wing Carry-Through Box Component Test Results

51 TEST FAILURE INCIDENTS
(BLOCK 20 of PLANNED 40 BLOCK SPECTRUM)

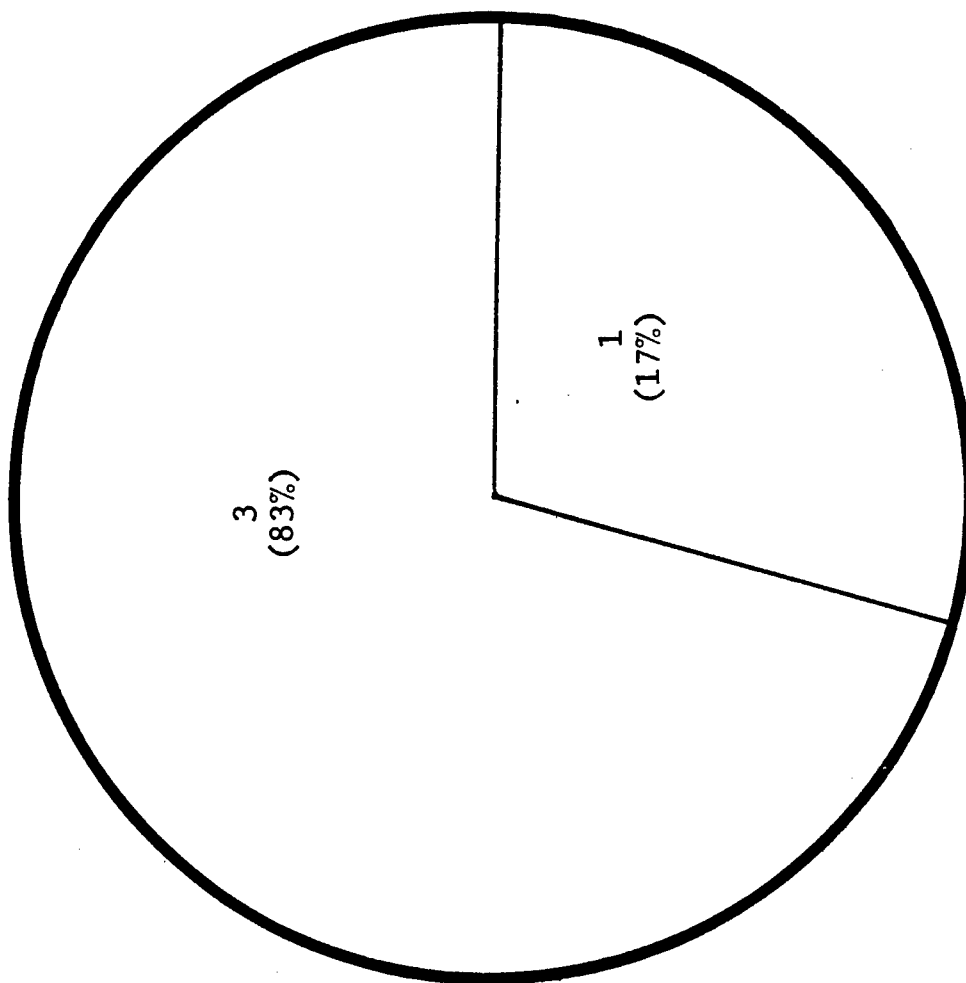
6 TEST INCIDENTS

(40000 (+) Equivalent Flight Hours)

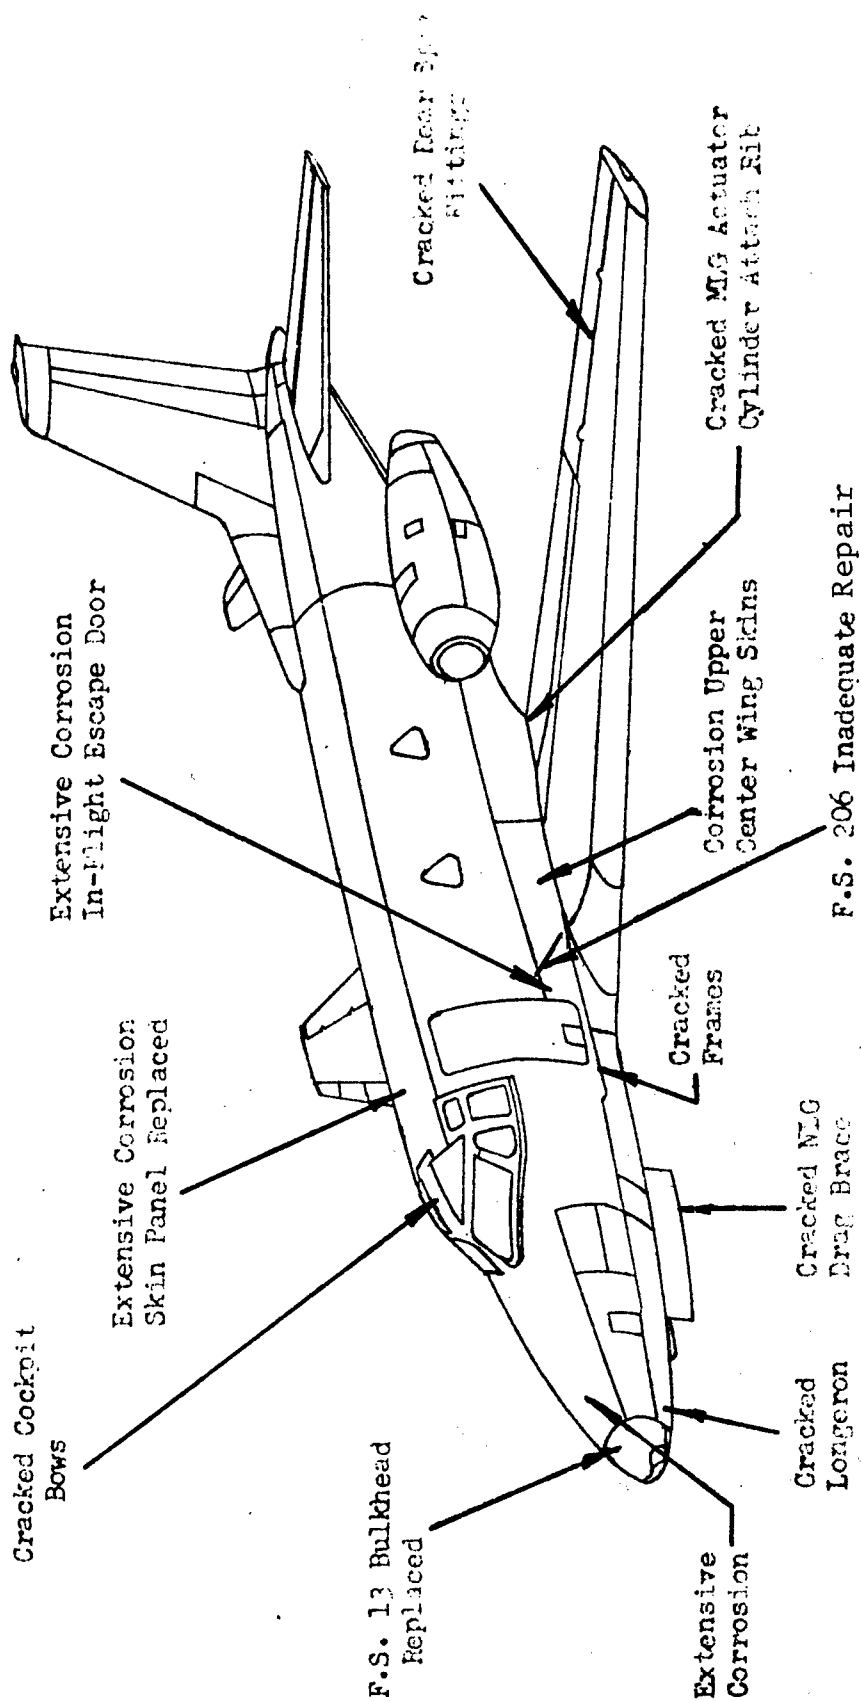
FIGURE 22 ACI FAILURE AREAS T-39A S/N
60-3490 PACAF/TAN SON NHUT

Figures 22 and 23 show the problem areas for two different aircraft.

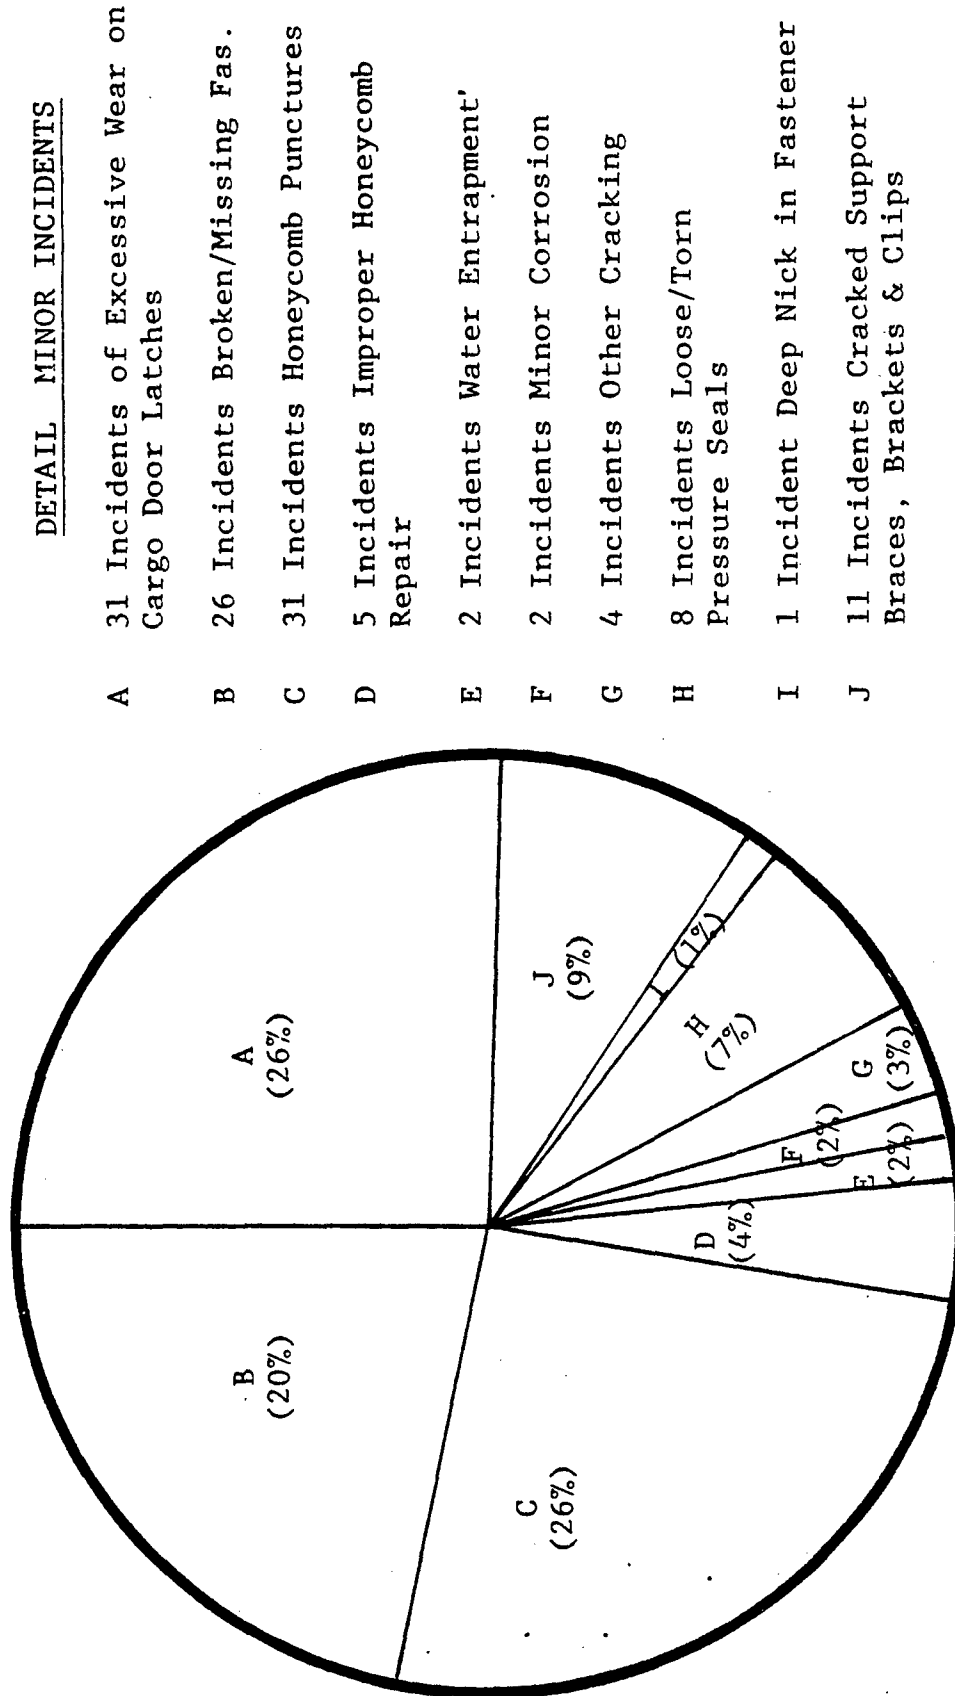
FIGURE 47 C-5A ACI Summary For CY 1976 (Minor Incidents)

121 MINOR INCIDENTS
(FROM INSPECTION OF 10 A/C)

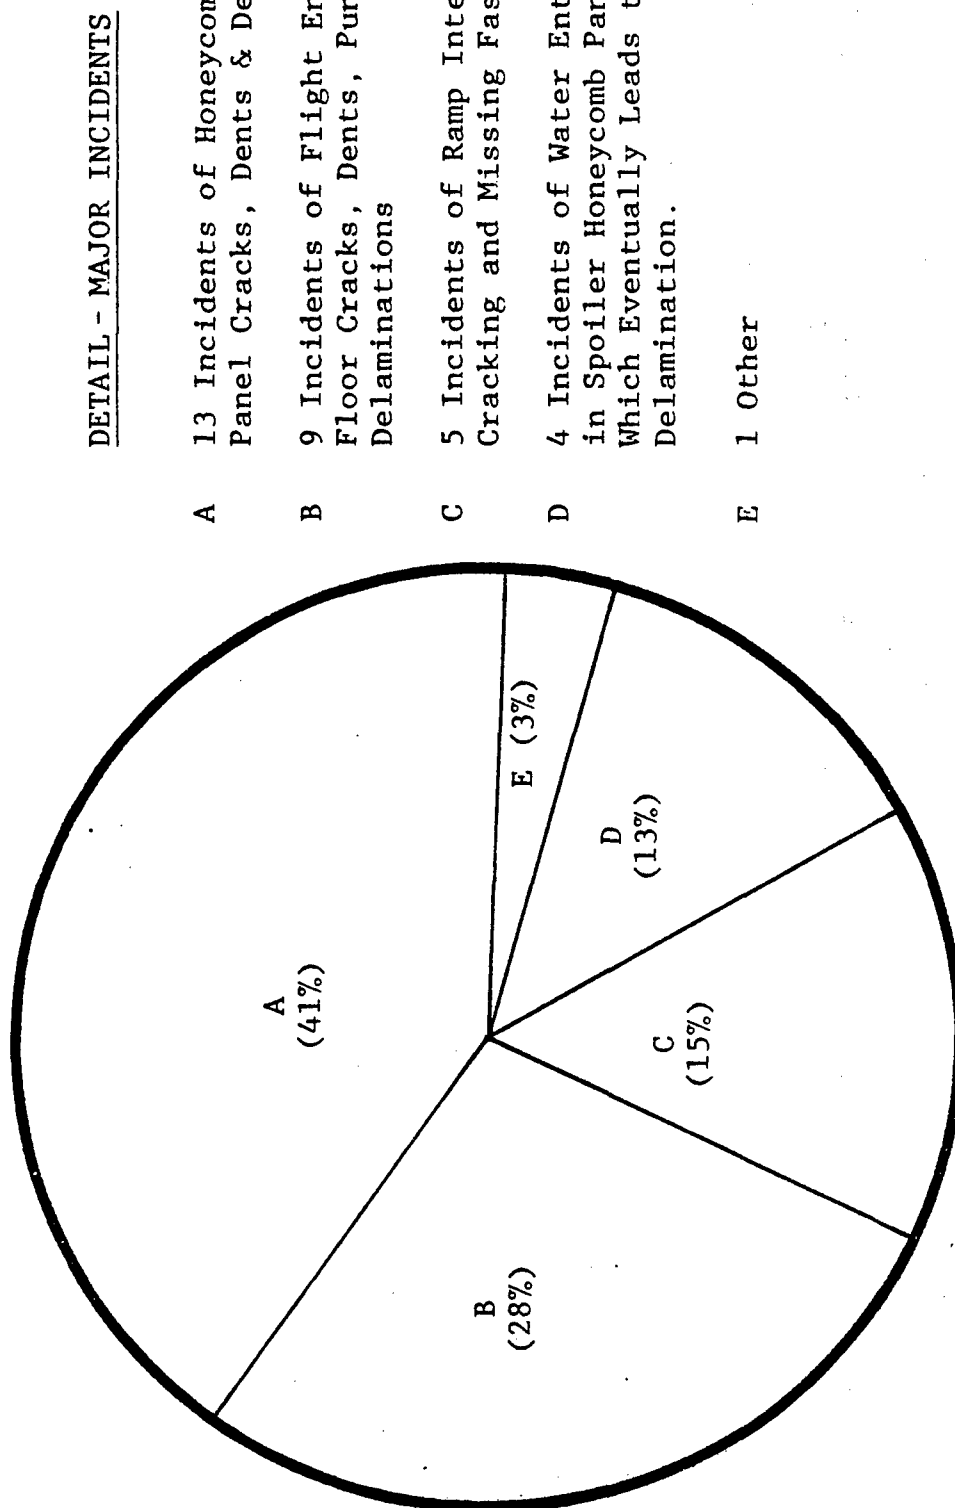
FIGURE 49 C-5A ACI Summary For FY 1977 (Major Incidents)

32 MAJOR INCIDENTS
(FROM INSPECTIONS OF 6 A/C)

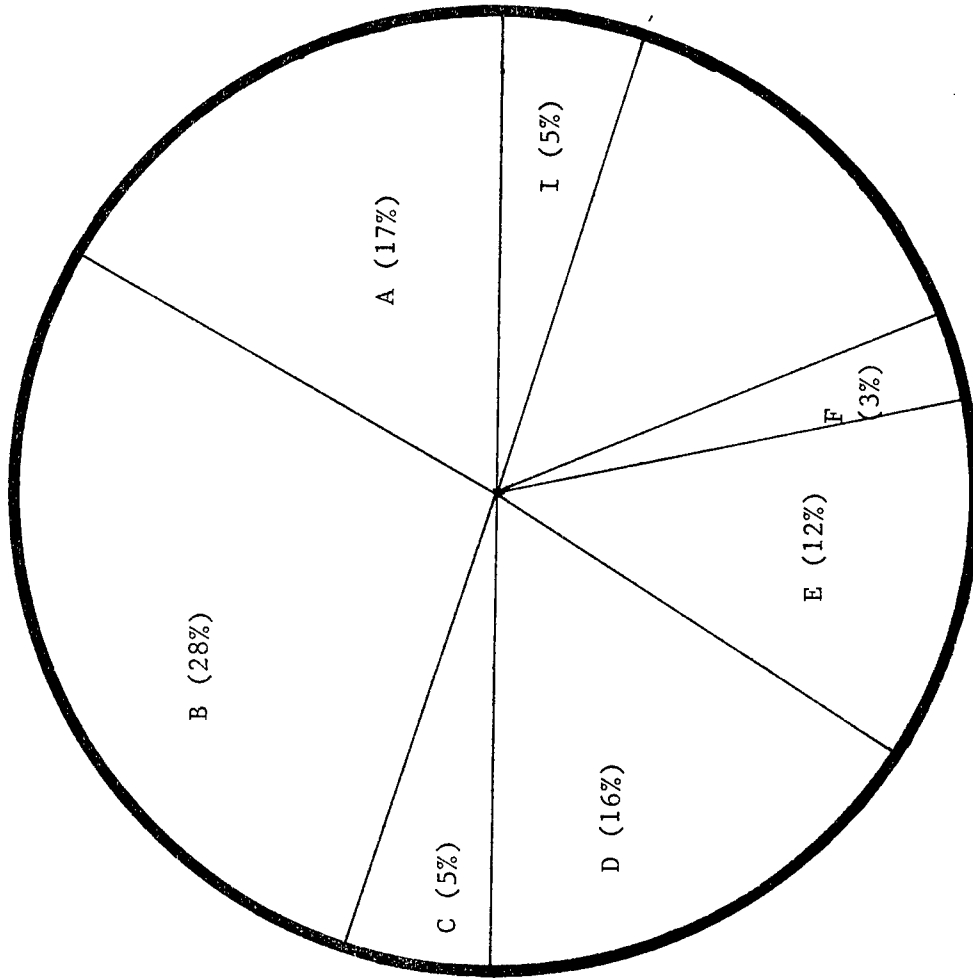
Figure 53 F/FB-111A Airframe Analytical Condition Inspection

64 Occurrences
